MATERION

CASE STUDY

OIL AND GAS VALVE FOR DRILL STEM TESTING

COMPETITIVE
MATERIAL ANALYSIS

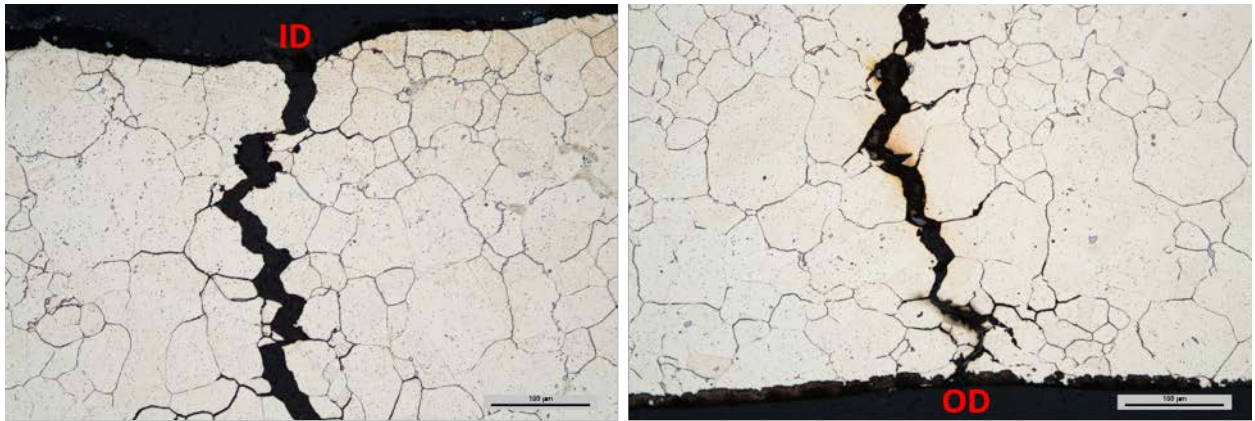
Observing the fracture with optical microscopy, it was determined that the part fractured from the inner diameter to the outer diameter. The fracture mode was from mechanical overloading, with some corrosion occurring after the fact as

indicated by the combined transgranular and intergranular primary crack with limited and uniformly dispersed corrosion between grain boundaries (**Figure 1**). Along the fracture surface, there are many shallow “divots” (**Figure 2**) present from corrosion. These divots may have caused weak points in the component and could have become crack initiation points.

Figure 1: Micrographs of fracture from ID (left) to OD (right); scale bars are 100µ

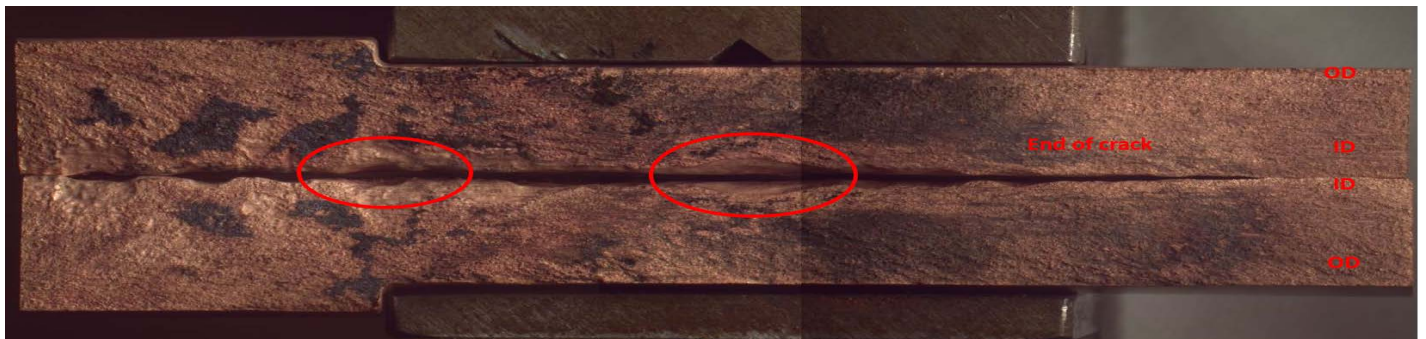
Figure 2: Fracture surface of the component, examples of divots circled in red

Evidence of severe corrosion was found throughout the component that would be expected from the aggressive sour environment. The corrosion created weak points within the mandrel in the form of divots, which is where the fracture may have initiated.

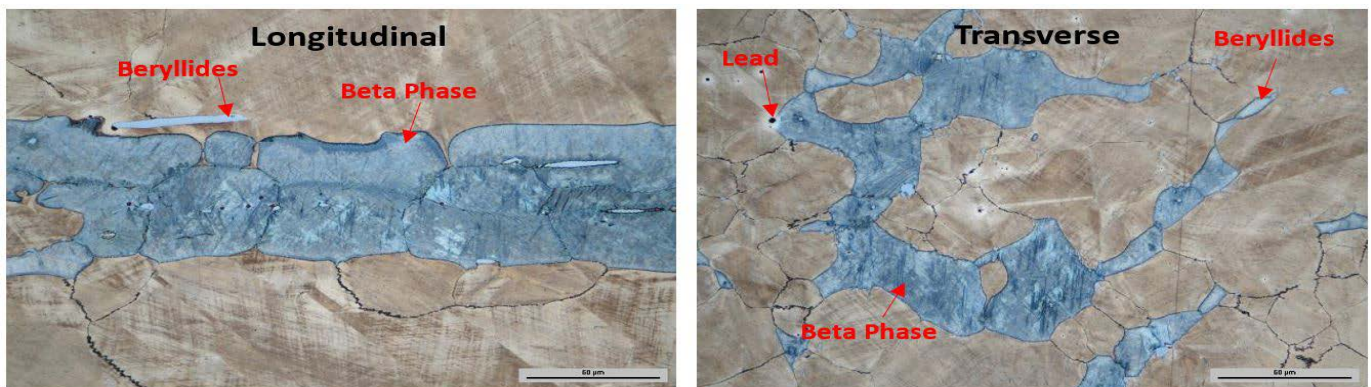
In addition, the material contained 0.068% lead, which was 0.048% higher than the customer specification, which allowed for 0.020% maximum (Table 2,3). For comparison, there is only trace tramp amounts of lead in Materion’s Alloy 25--historically less than 0.005%. This high amount of lead was apparent when looking in the microstructure shown in pictures below, appearing as small dark circles in the micrograph.

The overall microstructure (**Figure 3**) reveals—by Materion standards—abnormally large and elongated beta phase and beryllides. Beta phase is hard, brittle and undesirable in CI7200. It often appears due to excessive casting temperature or improper quenching. The high lead content is also visible and manifests as the small dark circles.

Figure 3: Competitor CI7200 microstructure shows large beta phase stringers, beryllide stringers and lead; scale bars are 50µm

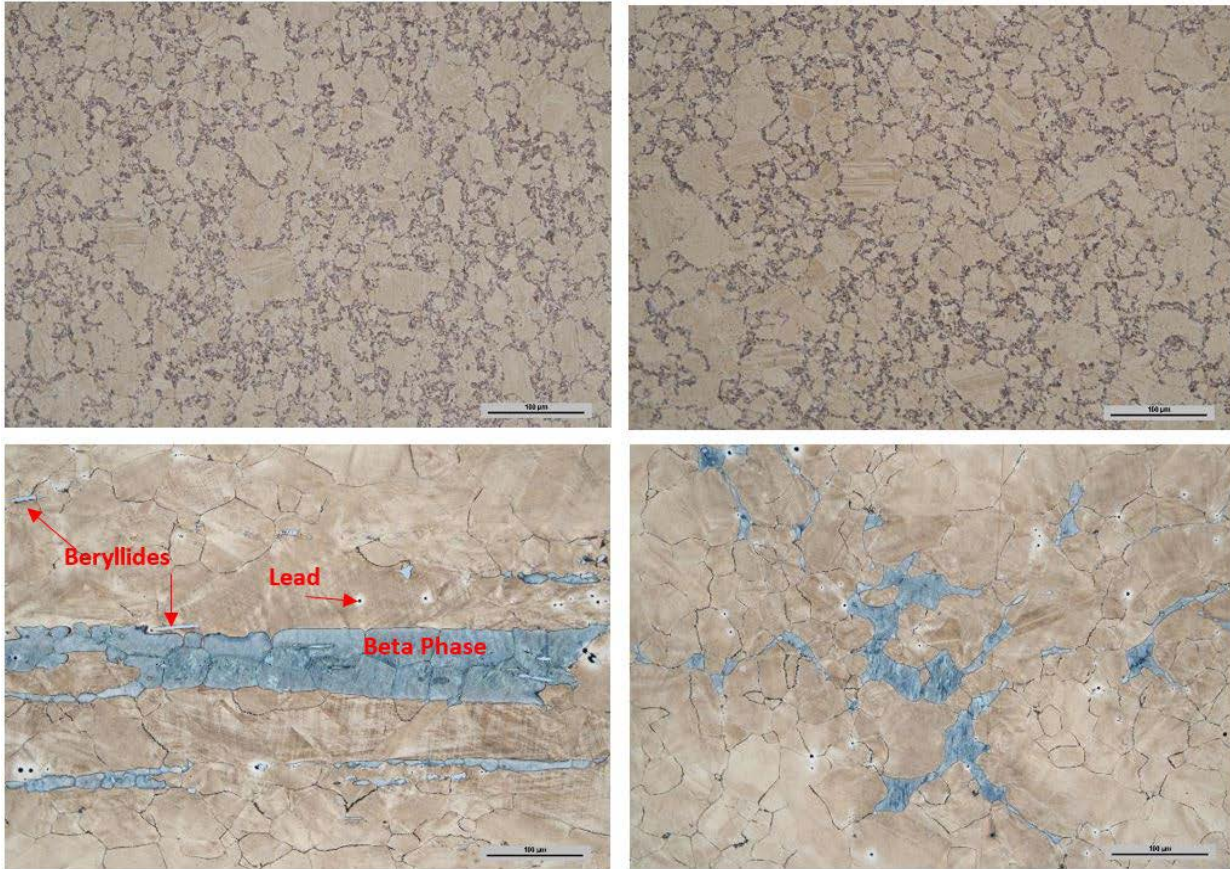
Figure 4 shows the difference between Materion Alloy 25 and the competitor material. Notice that Alloy 25 has a uniform, homogenous grain structure with no obvious beryllides, lead or beta phase. The competitor material contains elongated grains in the longitudinal direction, large beta phase stringers, beryllide stringers and lead.

Figure 4: Materion Alloy 25 (top) vs. competitor C17200 (bottom). Notice the Materion microstructure displays uniform, homogenous grain structure, no obvious beryllides, no beta phase and no lead. The competitor microstructure displays elongated grains in the longitudinal direction, large beta phase stringers, large beryllides and lead clusters throughout. Scale bars are all 100µm.
