Performance Materials

Stress Corrosion Cracking / Sulfide Stress Cracking Testing in NACE MR0175 and ASTM G36 Environments of Copper-Beryllium Alloys

1. EXECUTIVE SUMMARY

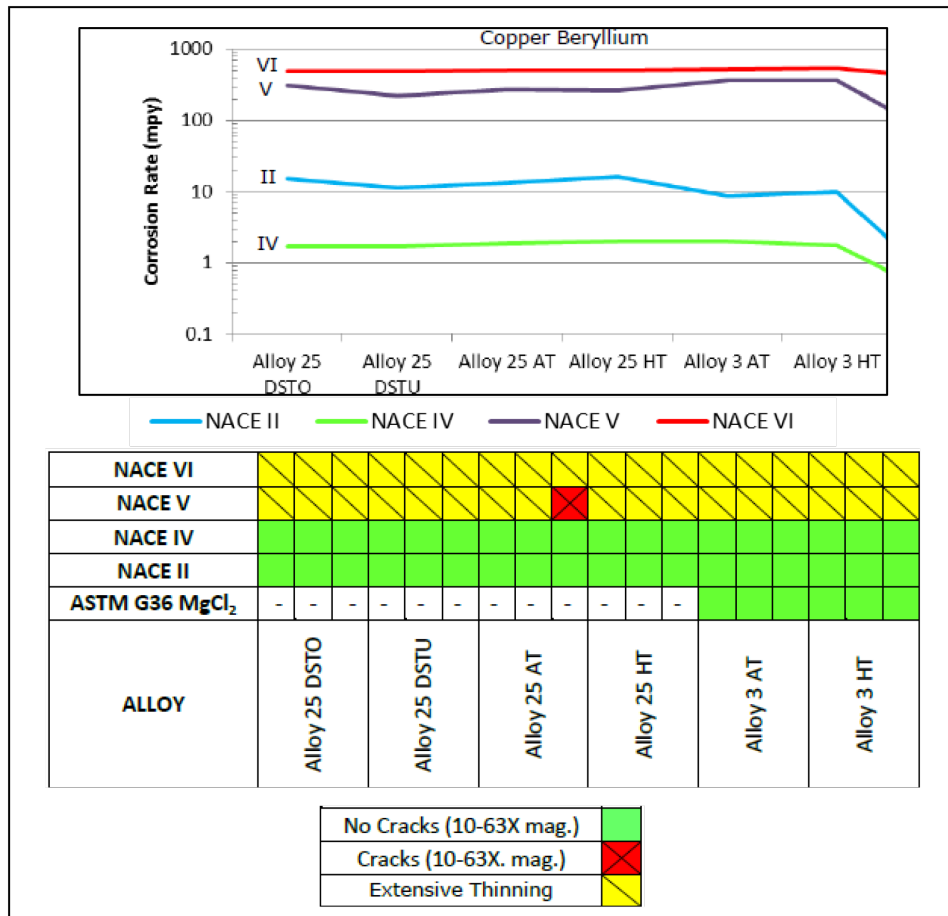
FIGURE 3
Graphical NACE MR0175 and ASTM G36 Boiling MgCl₂ Results

The first chart of Figure 3 represents the corrosion rate in mils per year (mpy) on the Y-axis vs. the alloy name/temper on the X axis. The results for NACE severity Level II are shown in blue, for NACE severity Level IV in green, the NACE severity level V in purple, and the NACE severity level VI in red.

The second chart of Figure 3 represents the cracking results obtained in this work. On the Y-axis the NACE severity level is listed (or ASTM G36 $MgCl_2$). On the X-axis, the alloy name/temper is listed. Three boxes are shown for each alloy type at a specific test condition. These three boxes represent the three tested specimens for that condition. Results shown in green are for specimens that passed the criteria (no cracks at 10-63x mag. for sour tests; no cracks at 20x mag. for ASTM G36); results shown in red are for those that failed the criteria (cracks evident at 10-63x mag. for sour tests; cracks evident at 20x mag. or during Materion post-test micrographic examination for ASTM G36); and results shown in yellow are those that displayed significant corrosion and specimen thinning (as evidenced by high corrosion rates in weight loss testing) which may have reduced the imparted stress on the specimen since they were loaded into fixed-displacement fixtures.

Figures 3 and 4 graphically represent the data presented in Table

NACE II: Table 4 and Figure 3 indicate that the alloys passed according to the cracking criterion (no cracks at 10-63x mag.) for NACE Level II for the materials and tests conducted in this work. The corrosion rate for these alloys ranged from 9 – 16 mpy at NACE Level II. The corrosion rate was lower for Alloy 3 compared to Alloy 25 in the NACE Level II exposure. There was visible grain boundary etching for Alloy 25, but minimal grain boundary attack for Alloy 3.

NACE IV: Table 4 and Figure 3 indicate that the alloys passed according to the cracking criterion (no cracks at 10-63x mag.) for NACE Level IV for the materials and tests conducted in this work. The corrosion rate for these alloys ranged from 1.7 – 2.0 mpy in NACE Level IV. The corrosion rate was similar for Alloy 3 compared to Alloy 25 in the NACE Level IV exposure. Widespread pitting was the main mode of observed attack for this test condition.

NACE V: Table 4 and Figure 3 indicate that the alloys passed according to the cracking criterion (no cracks at 10-63x mag.) for NACE Level V for the materials and tests conducted in this work, with the exception of Alloy 25 AT (the second-highest strength heat treatment level tested). However, the beams experienced significant thinning due to corrosion that would act to reduce the applied stress in the test since the fixtures were constant-deflection devices. The corrosion rates for the alloys were 224-365 mpy in NACE Level V. The corrosion

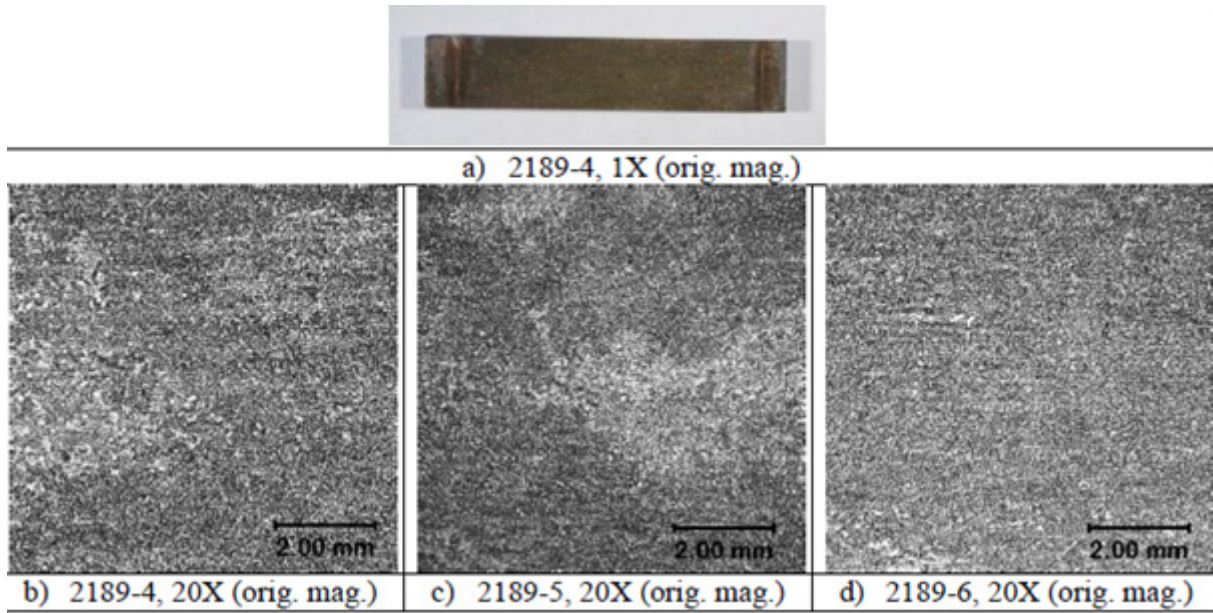
FIGURE 1

Test M2 - Alloy 3 AT - DNV# 2189 4PB; Boiling $MgCl_2$

ASTM G36 Boiling MgCl₂: Only the Alloy 3 specimens were exposed to the ASTM G36 Boiling MgCl₂ test, and these passed according to the 20x cracking criteria. However, Alloy 3 AT had questionable features on micrographic cross section that appear to be IGC and could turn into cracking. Alloy 3 HT showed IGC also but with shallower pit bottoms and wider aspect ratios.

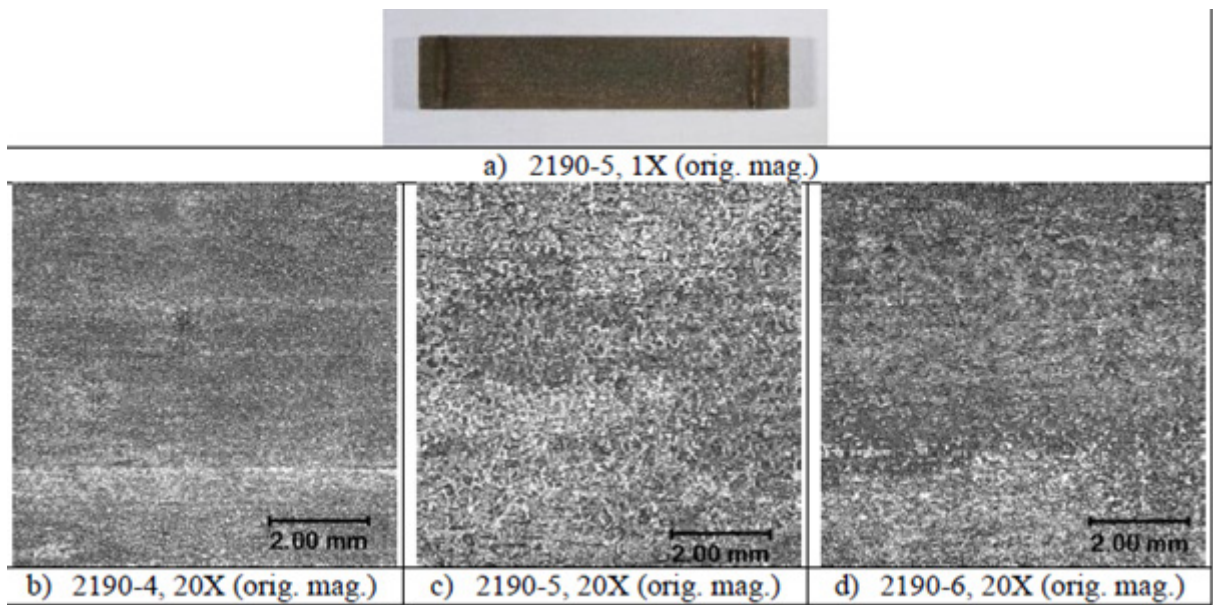
FIGURE 2

Test M2 - Alloy 3 HT - DNV# 2190 4PB; Boiling $MgCl_2$

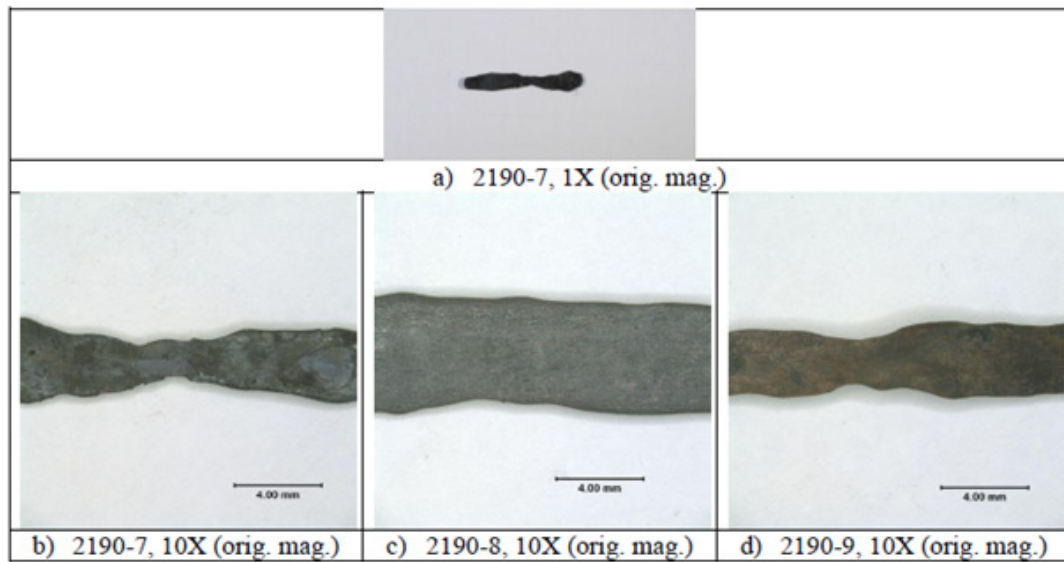
FIGURE 2

Test S7 - Alloy 3 HT - DNV# 2190 4PB; NACE Level V

rate was higher for Alloy 3 compared to Alloy 25. These alloys experienced significant thinning and had a wood grain appearance post-test (perhaps stress oriented pits) in the NACE Level V exposure.
