Testing Report: ToughMet® Alloy Comparison

Prepared By: Grant Crawford, PhD
Crawford Engineering and Consulting, LLC.

This study was originally conducted at the request of L&H Industrial. It has been reformatted slightly for broader distribution by Materion Corporation.

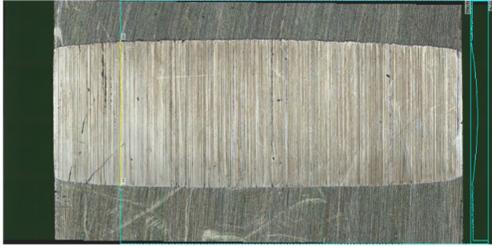
Sample 2

Profile1	Horz. dist.	Hght. diff.	Hght. ave.	Angle	C.S. length	Wear area	R	Comment
All	3797um	0um	76um	0°	4162um	48103um ²		
Seg.1	2247um	6um	71um	0°	2283um	39769um ²

- Wear scars were analyzed using laser scanning confocal microscopy.
- 5 profiles were measured for each sample to obtain an average wear scar width (one profile shown above for these samples).

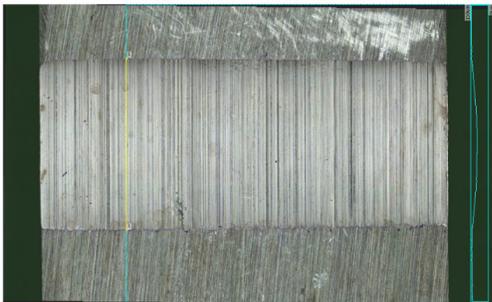
Sample 3

Profile1	Horz. dist.	Hght. diff.	Hght. ave.	Angle	C.S. length	Wear area	R	Comment
All	4690um	0um	123um	0°	5160um	95476um ²		
Seg.1	2680um	4um	113um	0°	2718um	81304um ²

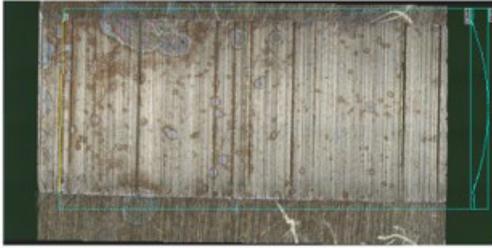
Sample 1

Profile1	Horz. dist.	Hght. diff.	Hght. ave.	Angle	C.S. length	Wear area	R	Comment
All	3123um	2um	86um	0°	3244um	77039um ²		
Seg.1	2648um	6um	82um	0°	2738um	76546um ²

- Wear scars were analyzed using laser scanning confocal microscopy.
- 5 profiles were measured for each sample to obtain an average wear scar width (one profile shown above for these samples).

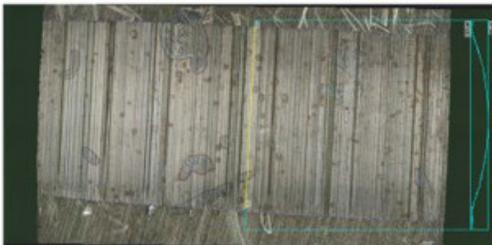
Sample 2

Profile1	Horz. dist.	Hght. diff.	Hght. ave.	Angle	C.S. length	Wear area	R	Comment
All	3251um	3um	69um	0°	3460um	96474um ²		
Seg.1	2786um	5um	65um	0°	2948um	96198um ²

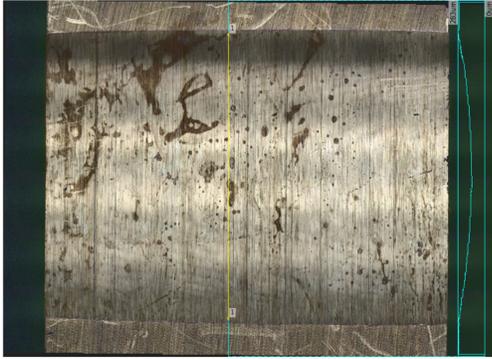
Sample 1

Profile1	Horz. dist.	Hght. diff.	Hght. ave.	Angle	C.S. length	Wear area	R	Comment
All	5567um	0um	199um	0°	6552um	422741um ²		
Seg.1	4441um	11um	184um	0°	4822um	410402um ²

- Wear scars were analyzed using laser scanning confocal microscopy.
- 5 profiles were measured for each sample to obtain an average wear scar width (one profile shown above for these samples).

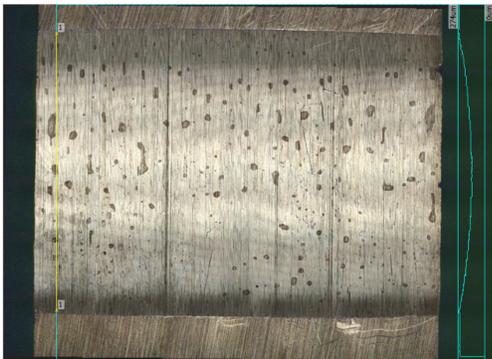
Sample 2

Profile1	Horz. dist.	Hght. diff.	Hght. ave.	Angle	C.S. length	Wear area	R	Comment
All	5567um	262um	191um	3°	6359um	402137um ²		
Seg.1	4329um	2um	175um	0°	4827um	386842um ²

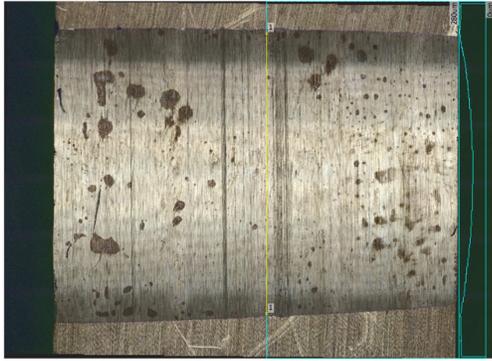
Mn Bronze - Sample 3

Profile1	Horz. dist.	Hght. diff.	Hght. ave.	Angle	C.S. length	Wear area	R	Comment
All	5567um	0um	193um	0°	6454um	366160um ²		
Seg.1	4374um	11um	179um	0°	4698um	356070um ²

- Wear scars were analyzed using laser scanning confocal microscopy.
- 5 profiles were measured for each sample to obtain an average wear scar width (one profile shown above for this sample).

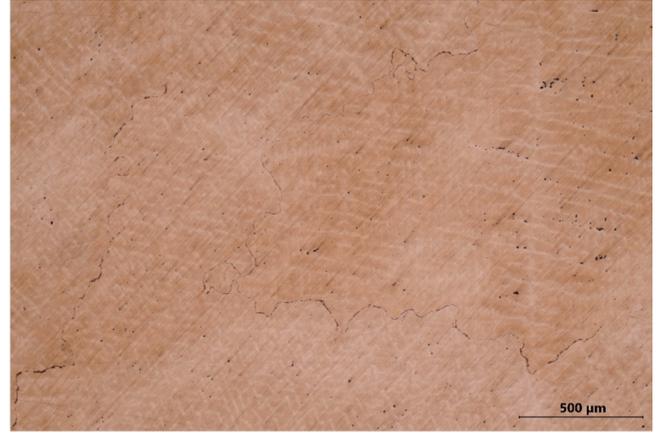
T3 CX105 – Location 1

- Location 1 of the T3 CX105 material reveals fine dendritic structure with limited microsegregation. The as-cast grain size again appears large but also appears to be uniform.
- Reduced microsegregation will result in a more uniform composition and improved strength when heat treated.
- Intermetallic particles are found throughout the grain interior and also located along grain boundaries.

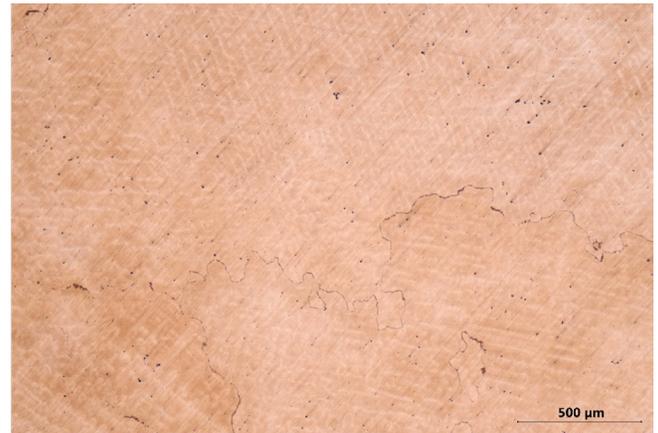
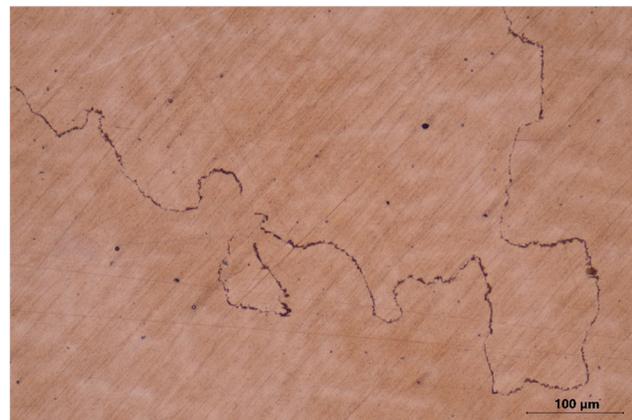
T3 CX105 – Location 2

- Location 2 of the T3 CX105 material once again reveals a fine dendritic structure with limited microsegregation. The as-cast grain size again appears large but uniform.
- Reduced microsegregation will result in a more uniform composition and improved strength when heat treated.
- Intermetallic particles are found throughout the grain interior and also located along grain boundaries.

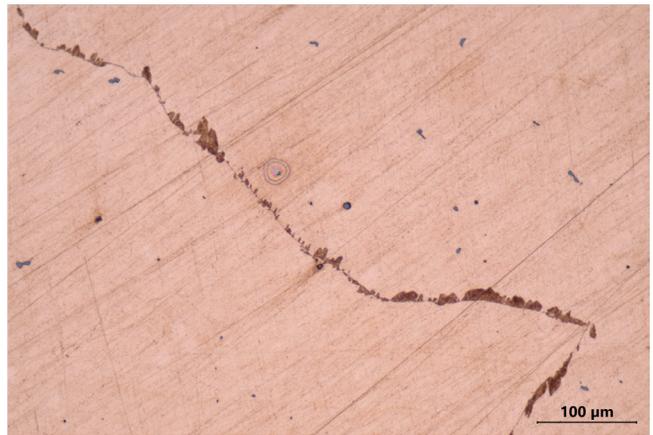
T2 CX90 – Location 1

- Location 1 of the T2 CX90 material reveals limited (if any) microsegregation. The as-cast grain size appears large but once again appears uniform.
- Reduced microsegregation will result in a more uniform composition and improved strength following subsequent heat treatment.
- Intermetallic particles are found throughout the grain interior and also located along grain boundaries.

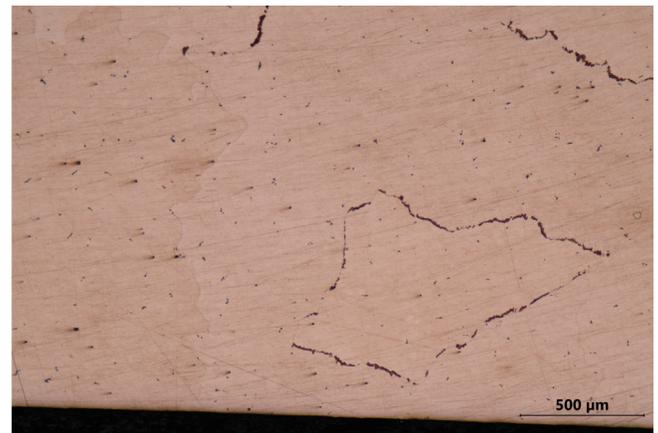
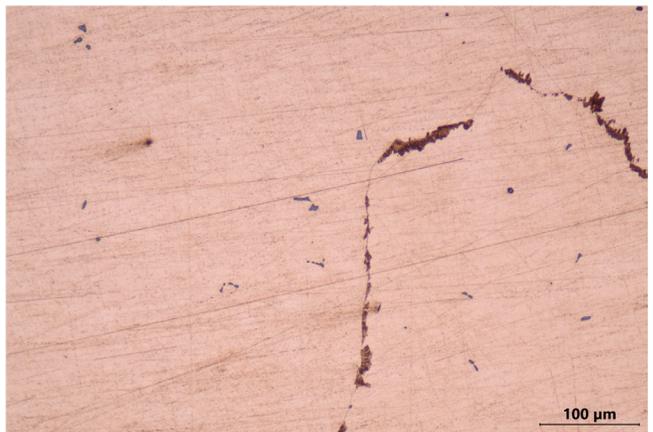
T2 CX90 – Location 2

- Location 2 of the T2 CX90 material reveals limited (if any) microsegregation. The as-cast grain size again appears large but uniform.
- Reduced microsegregation will result in a more uniform composition and improved strength following subsequent heat treatment.
- Intermetallic particles are found throughout the grain interior and also located along grain boundaries.

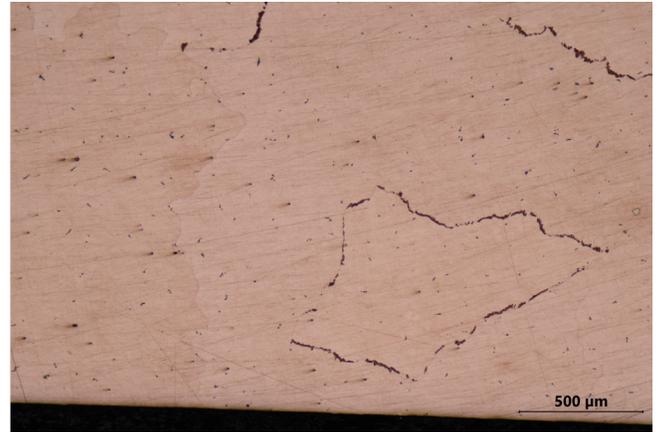
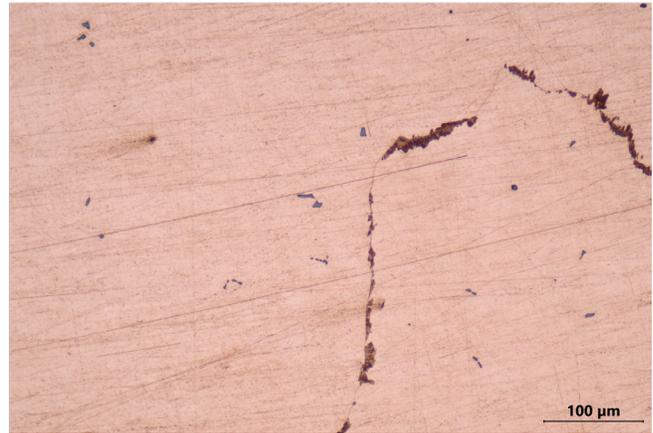
T2 CX90 – Location 2

- To confirm the limited microsegregation in T2 CX90 compared to T3 CX105 the specimen was re-polished and retched 4X longer than previous samples.
- These micrographs were obtained from Location 2, identical to that provided on the previous page.
- As can be observed here the specimen still does not show microsegregation.
- This material was heat treated substantially and simply contains reduced alloying element composition.
