ToughMet® 3 Alloy

Materion Partners with voestalpine to Provide Manufacturing Customer with Reliable Bushings and Pins

PROFILE: voestalpine Hungary

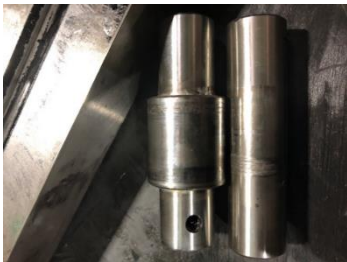
The frequent component failure was a result of galling and wear between the steel bushings and pins used in the equipment. Oftentimes, there was such severe galling that the pin and bushing were seized together, making it nearly impossible to separate the two pieces. Because the equipment runs 24 hours per day, seven days a week, this frequent and unplanned bushing failure led to unpredictable downtime and significant productivity issues.

Steel-on-steel bushing and pin stuck together due to extreme galling.

To create a solution, voestalpine partnered with Materion to provide a bushing material that could resist galling in this challenging environment. Materion supplied ToughMet 3 AT110 alloy, a high-strength, non-galling material that offers low friction and minimal wear. The bushings were manufactured with ToughMet alloy and voestalpine utilized their Vanadis 60 steel for the pins.

The combination of ToughMet 3 bushings with the Vanadis 60 pins consistently lasted for 12 weeks in the manufacturing equipment, compared with the unpredictable weekly replacements that had been previously needed. This significantly reduced downtime and enabled voestalpine's customer to improve overall productivity. Following the success of this project, the company developed plans to implement this same solution at each of the company's factories across the globe to prevent unexpected equipment maintenance.
